CAR MEDICS

Brake Inspection

Customer:	Car Medics Customer	License:	AVPXxxx
Vehicle:	2013 Dodge Grand Caravan	VIN:	2C4RDGDG6DR663xxx
Inspection date:	6/25/2020	Odometer:	in: 114,990- km
Repair Order #:	127441	Technician:	Shawn McCarthy, lic. # 310S-400151000

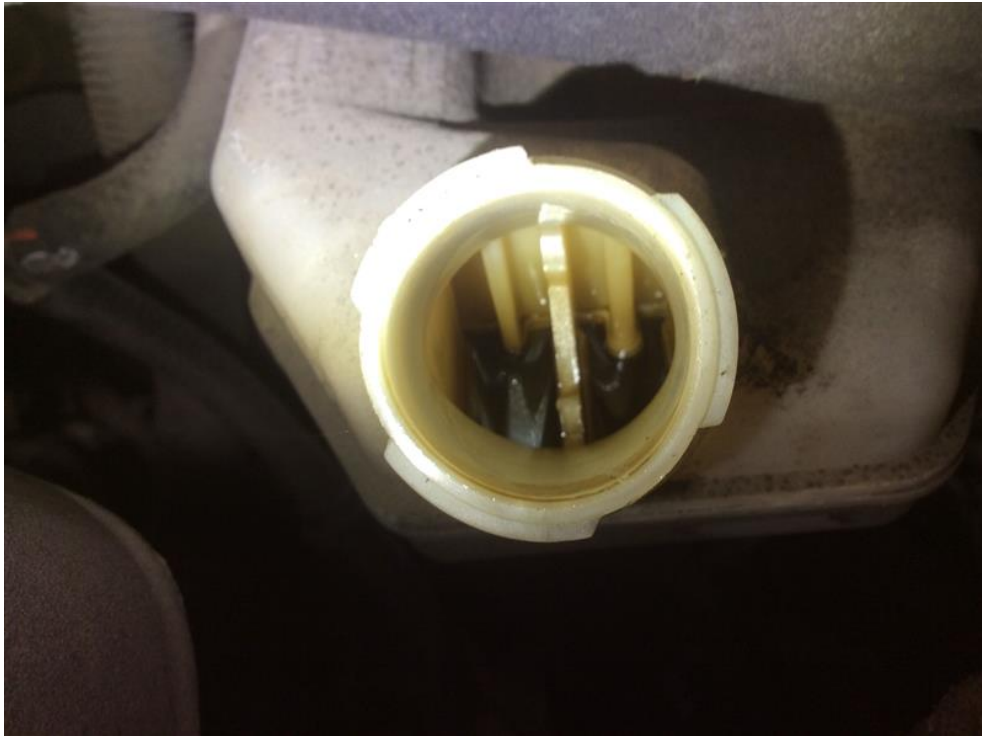
Inspection Items	Observation	Action
Power Steering Fluid	<p>Power steering fluid dirty</p> <p><i>Image(s):</i> https://tinyurl.com/yc3dqra5 <i>Right-hand mouse-click on link and select 'Open Link in New Tab'</i></p>	Recommend flushing power steering fluid
Other/Fluid Leaks/Noises/Steering/Suspension, etc.	<p>Other recommendation One of the rims is coated in brake dust</p> <p><i>Image(s):</i> https://tinyurl.com/yas8n52k <i>Right-hand mouse-click on link and select 'Open Link in New Tab'</i></p>

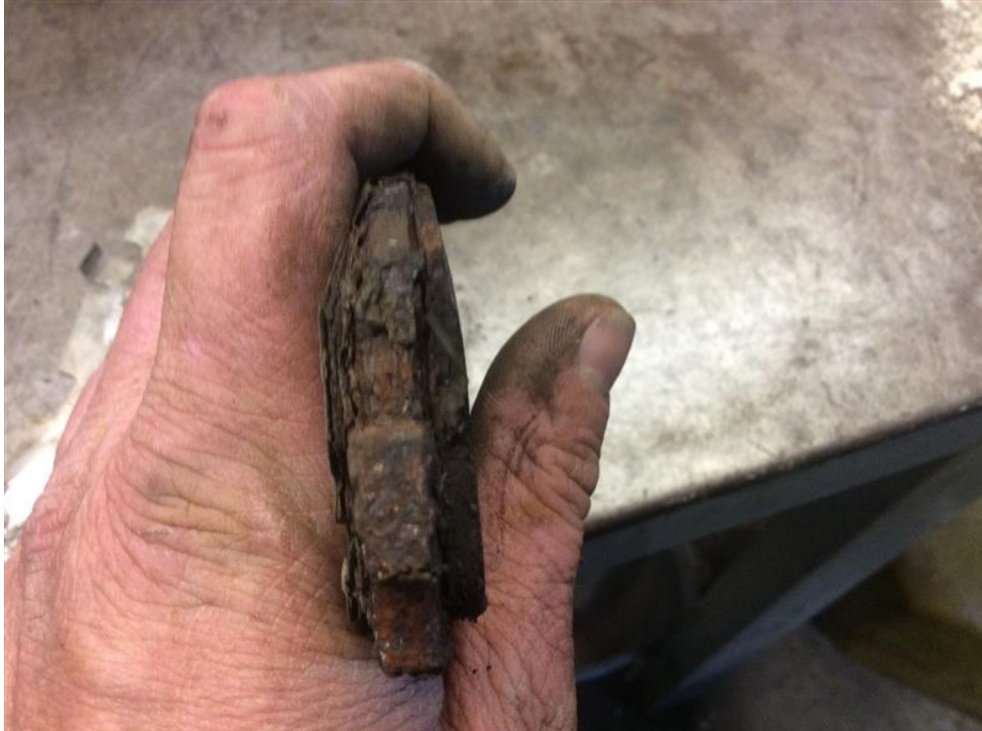
Brake Fluid	<p>Brake fluid low Brake fluid dirty</p> <p>2% Moisture contamination (maximum 2% for safe braking)</p> <p>Image(s): https://tinyurl.com/yd9sb37p <i>Right-hand mouse-click on link and select 'Open Link in New Tab'</i></p>	Recommend brake fluid flush
Warning Lamps	Check Engine Light ON	Recommend diagnostic
Front Brakes Pads and Rotors	<p>Front brake pads are metal on metal Front brake pads are seized in holders Front brake pads have uneven wear Front brake pads separating Front brake rotors rusted Front brake pad thickness remaining 0mm</p> <p>Image(s): https://tinyurl.com/y9p8bmot https://tinyurl.com/ya5wyu5d https://tinyurl.com/ycreyfha <i>Right-hand mouse-click on link and select 'Open Link in New Tab'</i></p>	Repair/replace today

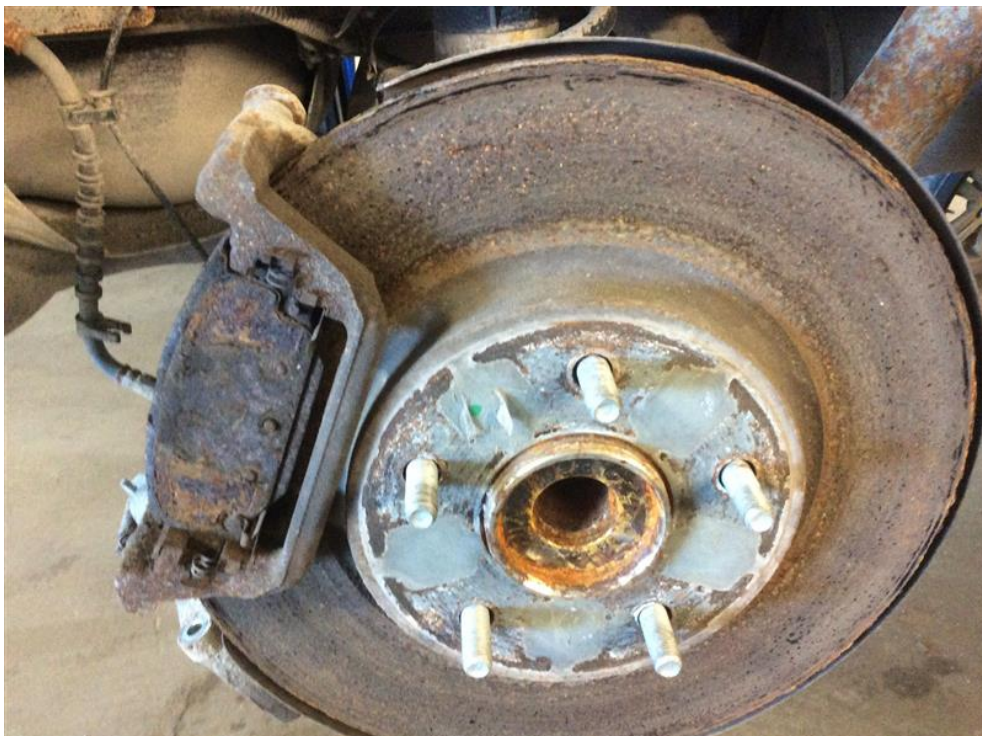
Rear Brakes Pads and Rotors	<p>Rear brake pads are metal on metal Rear brake pads are seized in holders Rear brake pads have uneven wear Rear brake rotors rusted Rear brake pad thickness remaining 0mm</p> <p><i>Image(s):</i> https://tinyurl.com/yahw5o8w https://tinyurl.com/y9nhp9ev <i>Right-hand mouse-click on link and select 'Open Link in New Tab'</i></p>	
Rear Brake Calipers or Wheel Cylinders	Caliper slider pins seized	Service rear brake calipers, pads and rotors today
